Flood Control Project Maintenance
2008 Structure Summary Report
Overall Unit and Item Ratings

Wetherbee Lake Pumping Plant & Navigation Gate

2008 Pumping Plant Inspection Results

Date of Inspection	11/14/2008
DWR Inspector	Hana Babbín
Pumping Plant Rating	A

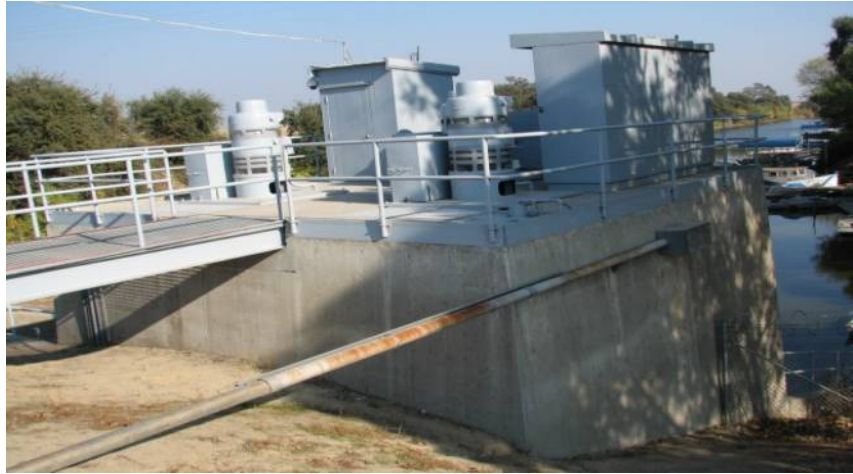
Report Line	3
Location	
Category	Pump Stations
Item	Plant Building

A view of the pump building. Appears very clean and maintained.

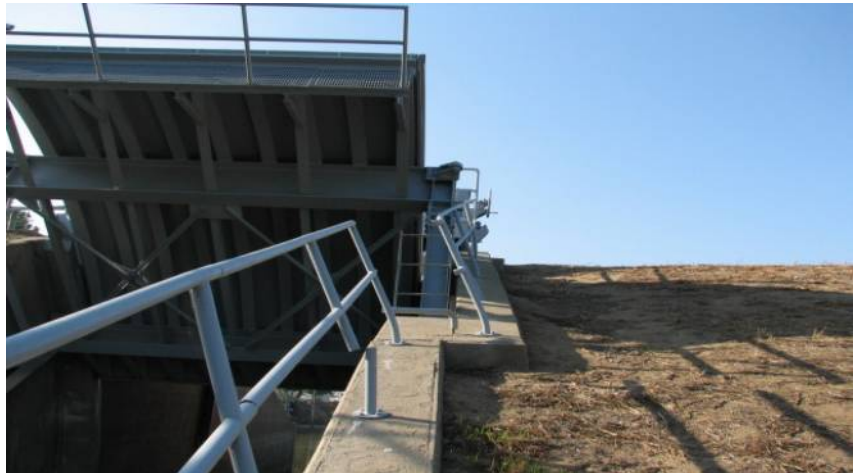
Report Line	5
Location	
Category	Pump Stations
Item	Safety

View of broken metal pipe railing. Minor safety concern.

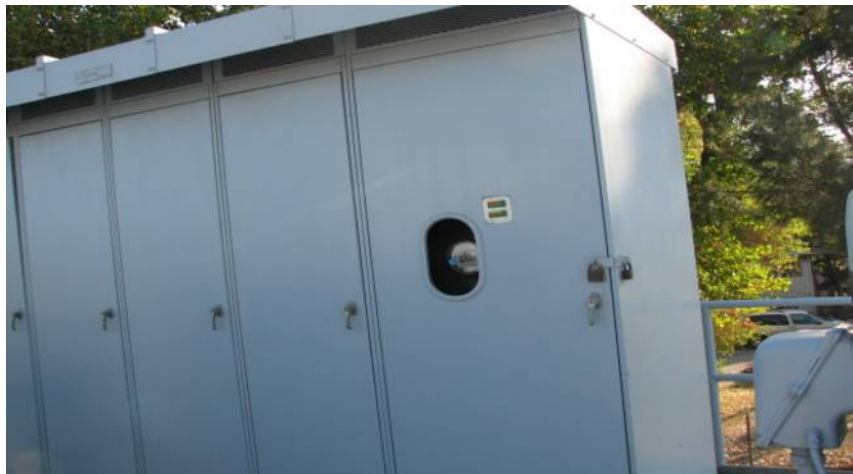
Report Line	8
Location	
Category	Pump Stations
Item	Power

Inspector assumes the power source is inside.

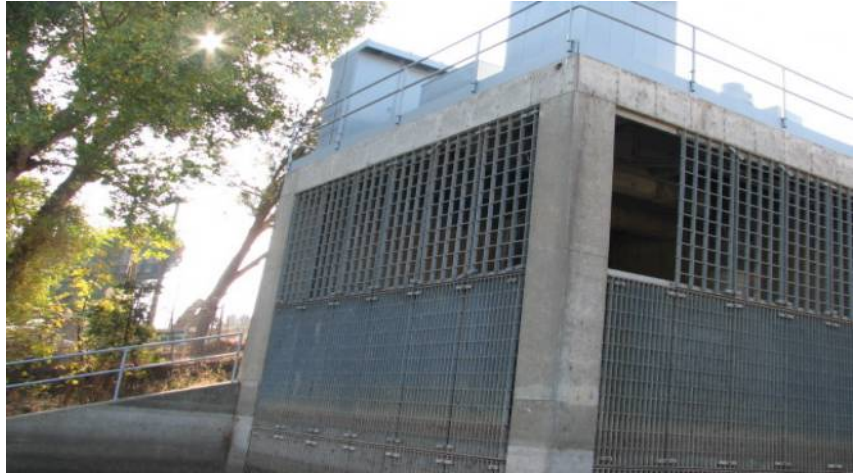
Report Line	12
Location	
Category	Pump Stations
Item	Trash Racks

View of trash racks.

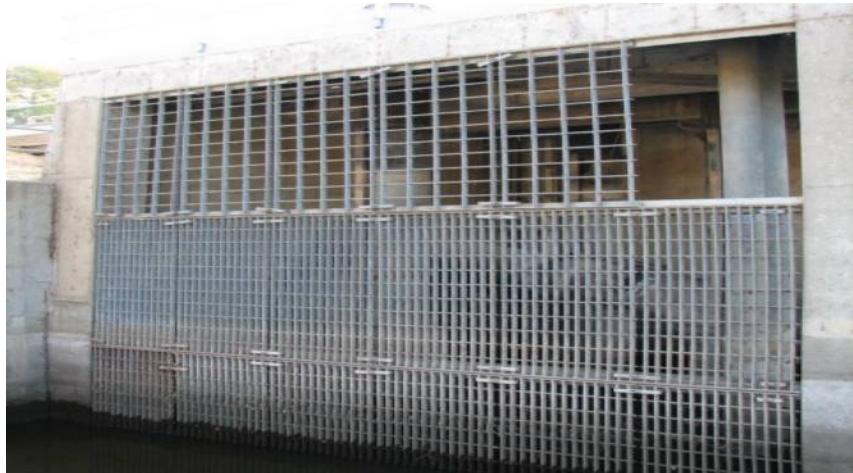
Report Line	12
Location	
Category	Pump Stations
Item	Trash Racks

View of trash racks.

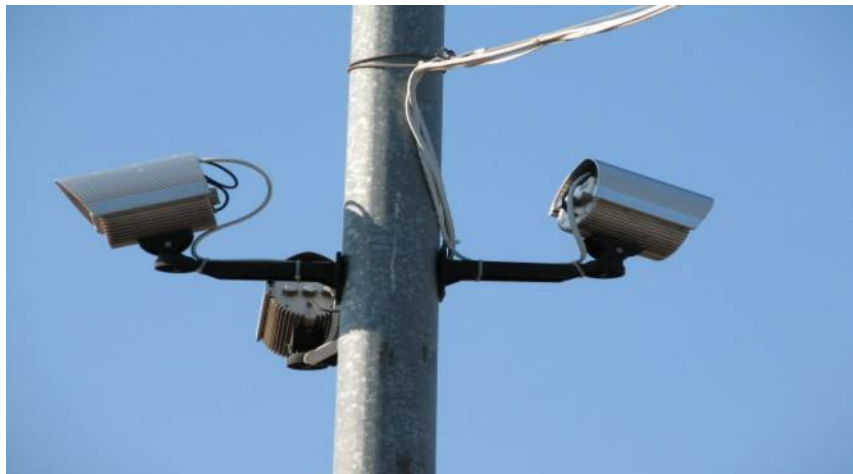
Report Line	20
Location	
Category	Pump Stations
Item	Security Fencing

Camera's are in place-whether or not they are monitored is unknown.

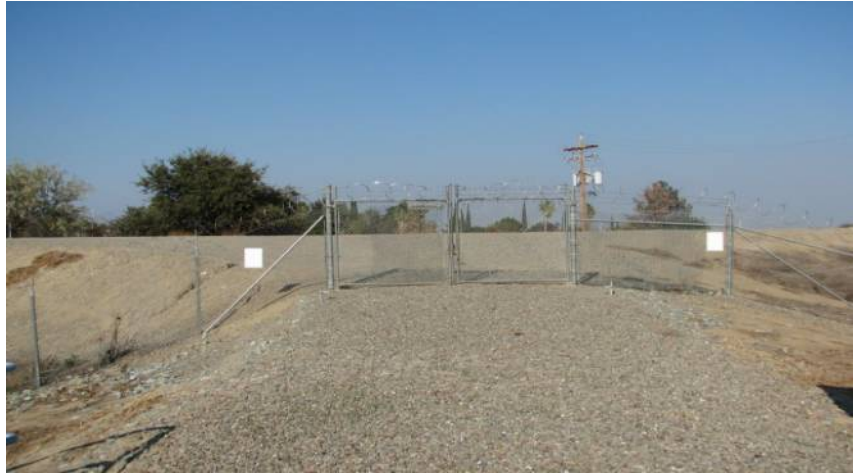
Report Line	20
Location	
Category	Pump Stations
Item	Security Fencing

View of fencing.

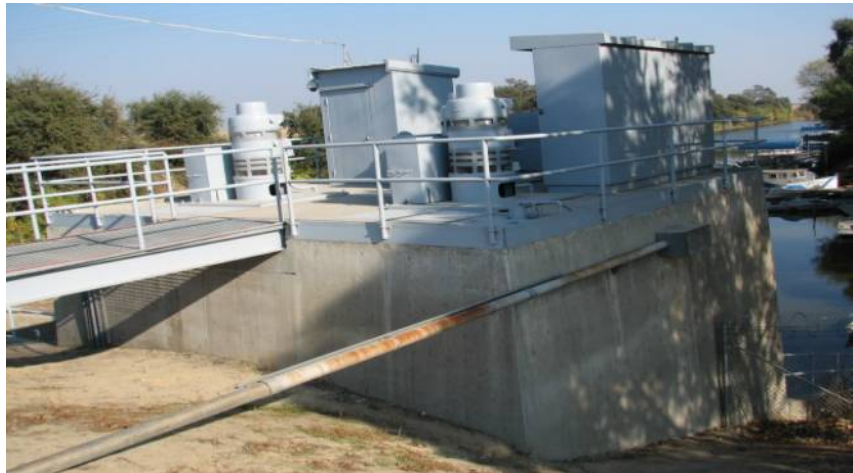
Report Line	21
Location	
Category	Pump Stations
Item	Intake and Discharge Pipes

View of pipe. No holes or leaks were visible.
Shape is still circular.

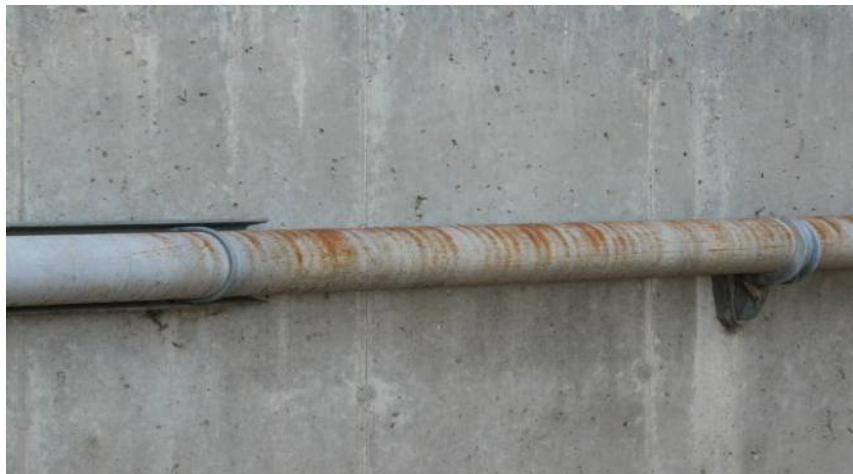
Report Line	21
Location	
Category	Pump Stations
Item	Intake and Discharge Pipes

Closer view.
